Twelve channel optical fiber connector assembly: from commercial off the shelf to space flight use

Melanie N. Ott, Swales Aerospace/ Code 562 Goddard Space Flight Center^a
Joy Bretthauer, Code 561 Goddard Space Flight Center
Greenbelt MD 20771

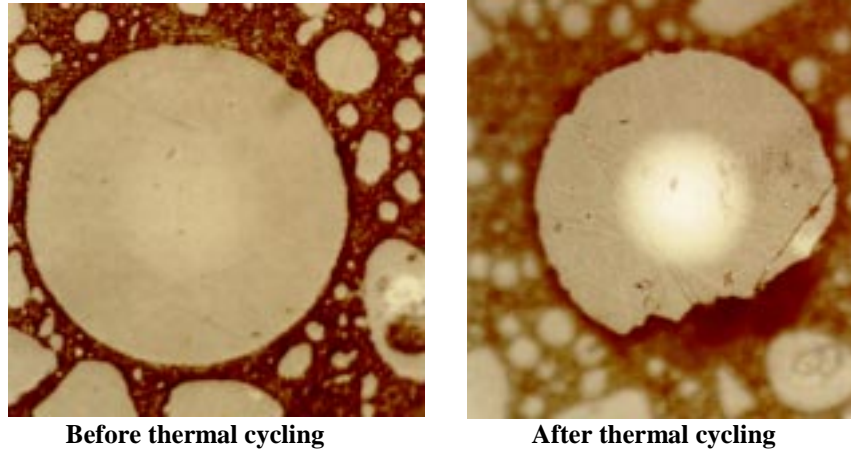
Figure 12: Before and after photographs of the optical fiber endface channel 12, cable set 2.
